Building Condition Assessment

The George Krabbenhoeft House c 1888

716 W. 5th Street, Davenport, Iowa

Marion Meginnis
HP 634 Preservation Technology

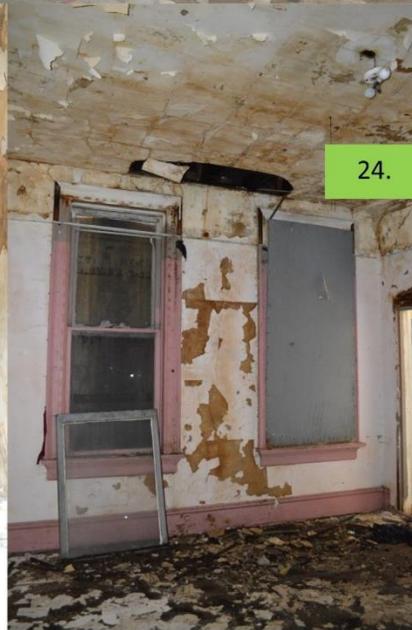
24.

- The cross gable section of the roof is sound but shingles are in poor condition. Roof holes approximately two and three feet in diameter located at two valleys near the south elevation are allowing water to enter the interior at the attic. Damage created by this condition is evident even in parts of the first floor. (19, 24, 28, 32, 40, 41)

- Wood floors are generally in good condition. One is covered with vinyl or asbestos tile. (20, 23)
- Some damage is present to ceilings in front parlors and to floor in east parlor due to moisture from above. (24, 41)
- Paint is peeling from ceilings and walls. (18, 24)
- Original trim, doors and most staircase elements are intact. (18,22)

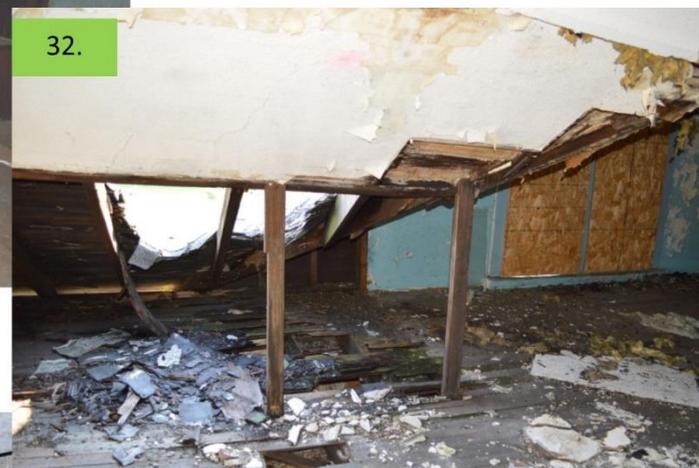
32. Looking S, hole in roof at east valley in attic.

- Holes at valleys and floor damage are clearly visible. (32)
- Balance of flooring seems structurally sound.
- Staircase from second floor is structurally sound.
- There is some damaged to finished ceilings due to water incursion or vandalism. (31)
- Some sashes are missing with windows covered by storms.

Item	Location	Floor	Description	Action to be Taken	Priority	Time Frame
Roof valleys	Ext	NA	Holes are allowing water into interior, damaging internal elements.	Make emergency repairs with rolled roofing. Add temporary interior horizontal bracing across valleys, set on sound joists.	1	1
Rear Section	NE corner, N Elevation	2	Cantilevered section is dangerously deteriorated.	Add additional temporary support from ground level across second floor joists. Starting at the roof, remove entire cantilevered second floor section, retaining joists. Seal exposed interior walls with weatherproof materials. Retain reusable materials in dry area.	1	1
Rear Section	NW corner, N Elevation	2	Area has severe damage and may not be salvageable, but does have some support from the first floor walls.	Install rolled roofing across shed roof to slow moisture penetration into interior. Secure door.	1	1
Joists	Rear section, all rooms	Roof and all floors	All roof and floor joists exposed to severe water damage on all floors	From a safe position, open floors and ceilings to assess condition and to check for mold. Replace or repair. Assessment might result in removal of portions of the second floor.	1	2

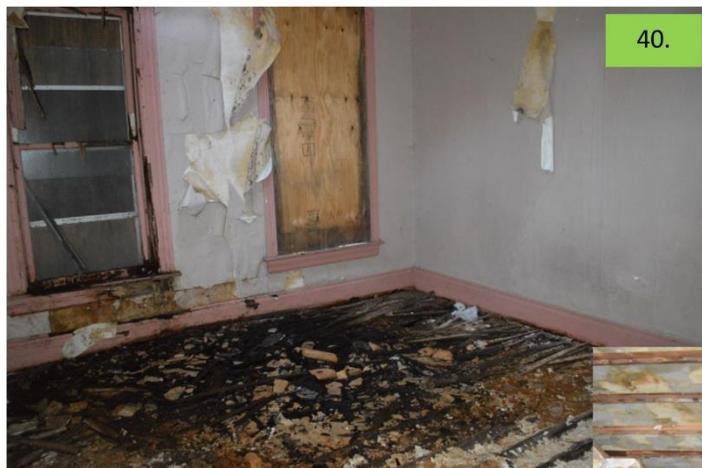
- Original doors and trim are intact, some with original finishes. (26, 27)
- Bedroom ceilings are severely damaged and floor boards warped from roof moisture. (40)
- There is some ceiling and floor damage to sitting room and dining room, but they and the hallway appear sound. (27,29)
- Animal scat (raccoon) was observed on second floor.

40. Looking SW, second floor, condition of floor in west bedroom.
41. Looking SW, first floor, fallen plaster in parlor below bedroom.

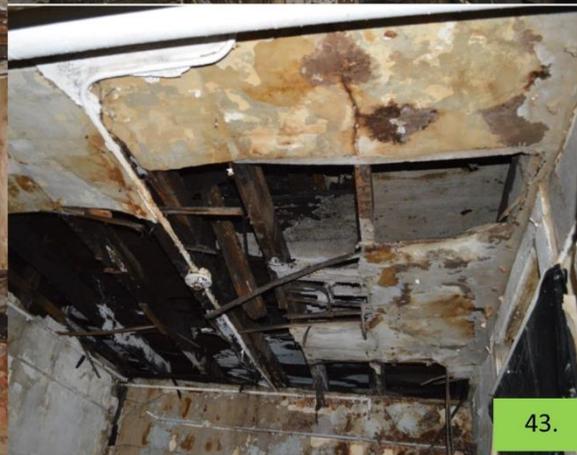
house, other intact walls and framing could be compromised. (36, 37, 42, 43)

- Ceiling and wall plaster is damaged or missing. (21, 43)
- Chimney stack has collapsed on north wall of kitchen. (44)
- Floors are too covered with debris to walk into area. (21)
- Ceiling in kitchen was covered with later acoustical tiles that have fallen. (44)

- Electrical service is generally via wire mold on walls and ceilings and does not meet current code due to age and condition. (43)
- No plumbing is in evidence and kitchens and bathrooms have been removed or are located in inaccessible areas.
- Ducting for forced air furnace is intact in basement; some grates are missing.

42. Looking N, second floor, room at NW corner; daylight is visible.
43. Looking N, first floor, ceiling below room in #42. Wire mold electrical service.
