Building Condition Assessment

The George Krabbenhoeft House c 1888

716 W. 5th Street, Davenport, Iowa

October 2016

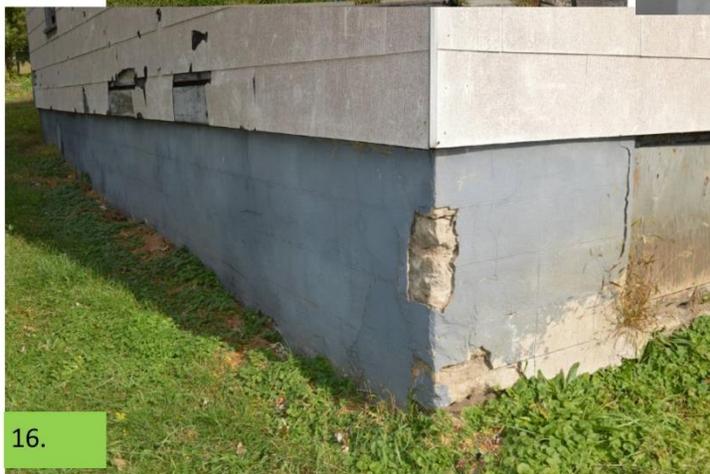
16. Looking NE, front corner parking and damage.

- The second floor east side bay retains its original siding and trim and appears structurally sound but in need of paint. (8, 9)
- On all sides, viewed from both the exterior and interior, the foundation appears square and true. It has lost a small amount of parging at some corners and basement window openings and in the basement interior, a plaster coating on the limestone has detached. (16, 33)

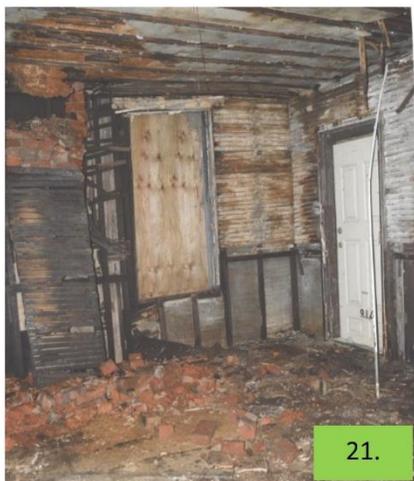
- 18. Looking N, staircase.
- 19. Looking SW, west parlor.
- 20. Looking NE, dining room.
- 21. Looking NE, kitchen.
- 22. Looking S, example of first floor ogee trim.
- 23. Looking SW, northeast parlor.
- 24. Looking SW, east parlor.

- Lack of maintenance and a flat design which does not easily shed water or snow has caused the shed roof on the north elevation to fail. The second and first floor rooms beneath this roof have lost most of their ceiling plaster and a considerable amount of ceiling lath and wall plaster due to this failure. (10, 21, 25, 44)

- Ceiling and wall plaster is damaged or missing. (21, 43)
- Chimney stack has collapsed on north wall of kitchen. (44)
- Floors are too covered with debris to walk into area. (21)
- Ceiling in kitchen was covered with later acoustical tiles that have fallen. (44)

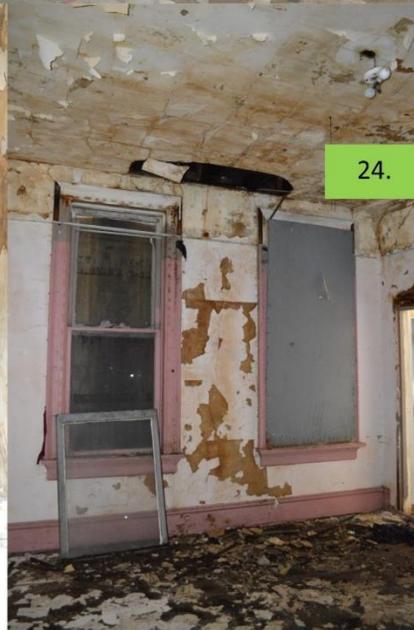
24.

- Wood floors are generally in good condition. One is covered with vinyl or asbestos tile. (20, 23)
- Some damage is present to ceilings in front parlors and to floor in east parlor due to moisture from above. (24, 41)
- Paint is peeling from ceilings and walls. (18, 24)
- Original trim, doors and most staircase elements are intact. (18,22)

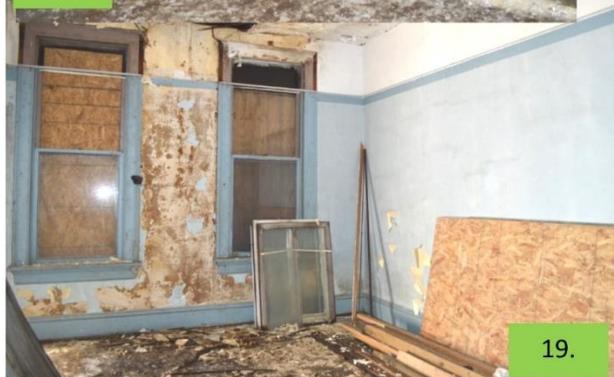
19.

- The cross gable section of the roof is sound but shingles are in poor condition. Roof holes approximately two and three feet in diameter located at two valleys near the south elevation are allowing water to enter the interior at the attic. Damage created by this condition is evident even in parts of the first floor. (19, 24, 28, 32, 40, 41)

- All exterior doors are modern metal units inappropriate to an historic home. (25)
- Window openings are securely boarded on the exterior, with no moisture apparent on interior surfaces. Some sills have failed. Application of the asbestos siding might have brought changes to exterior window trim and casings. Full assessment will require removal of boarding materials. (19, 39)

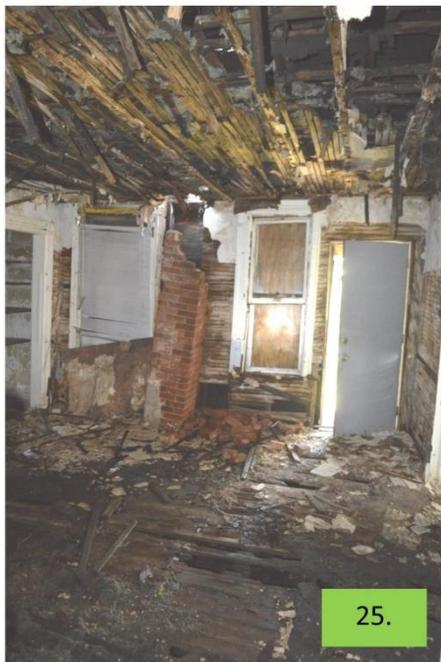
25. Looking N, kitchen with severely damaged roof and modern metal door.

- All structural elements of kitchen appear severely damaged and room is littered with debris. (25)
- Exterior view of bathroom (inaccessible) is of a sagging wall and section open on exterior. (42)

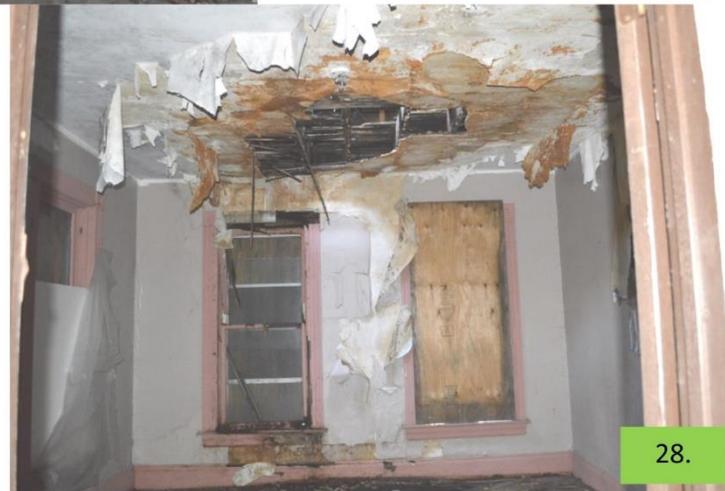
28. Looking S, west bedroom, severe ceiling damage.

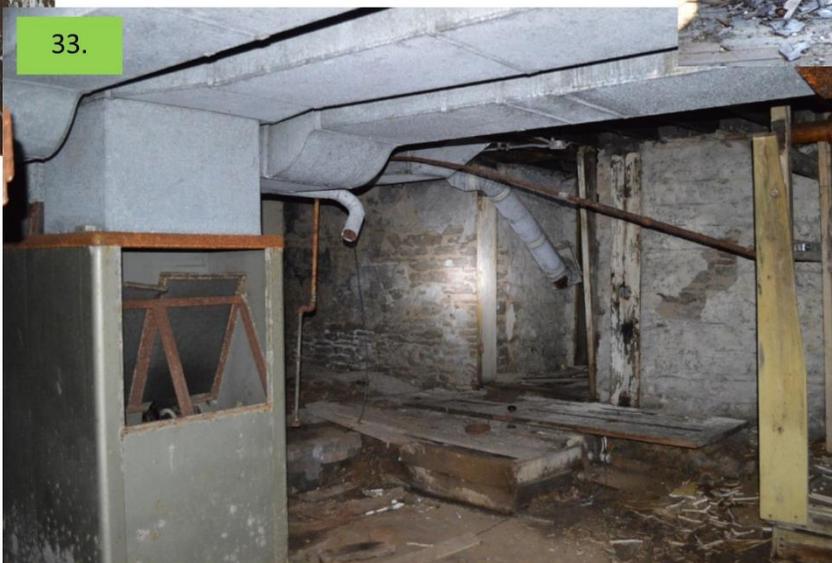
33. Looking NW, basement. General condition.

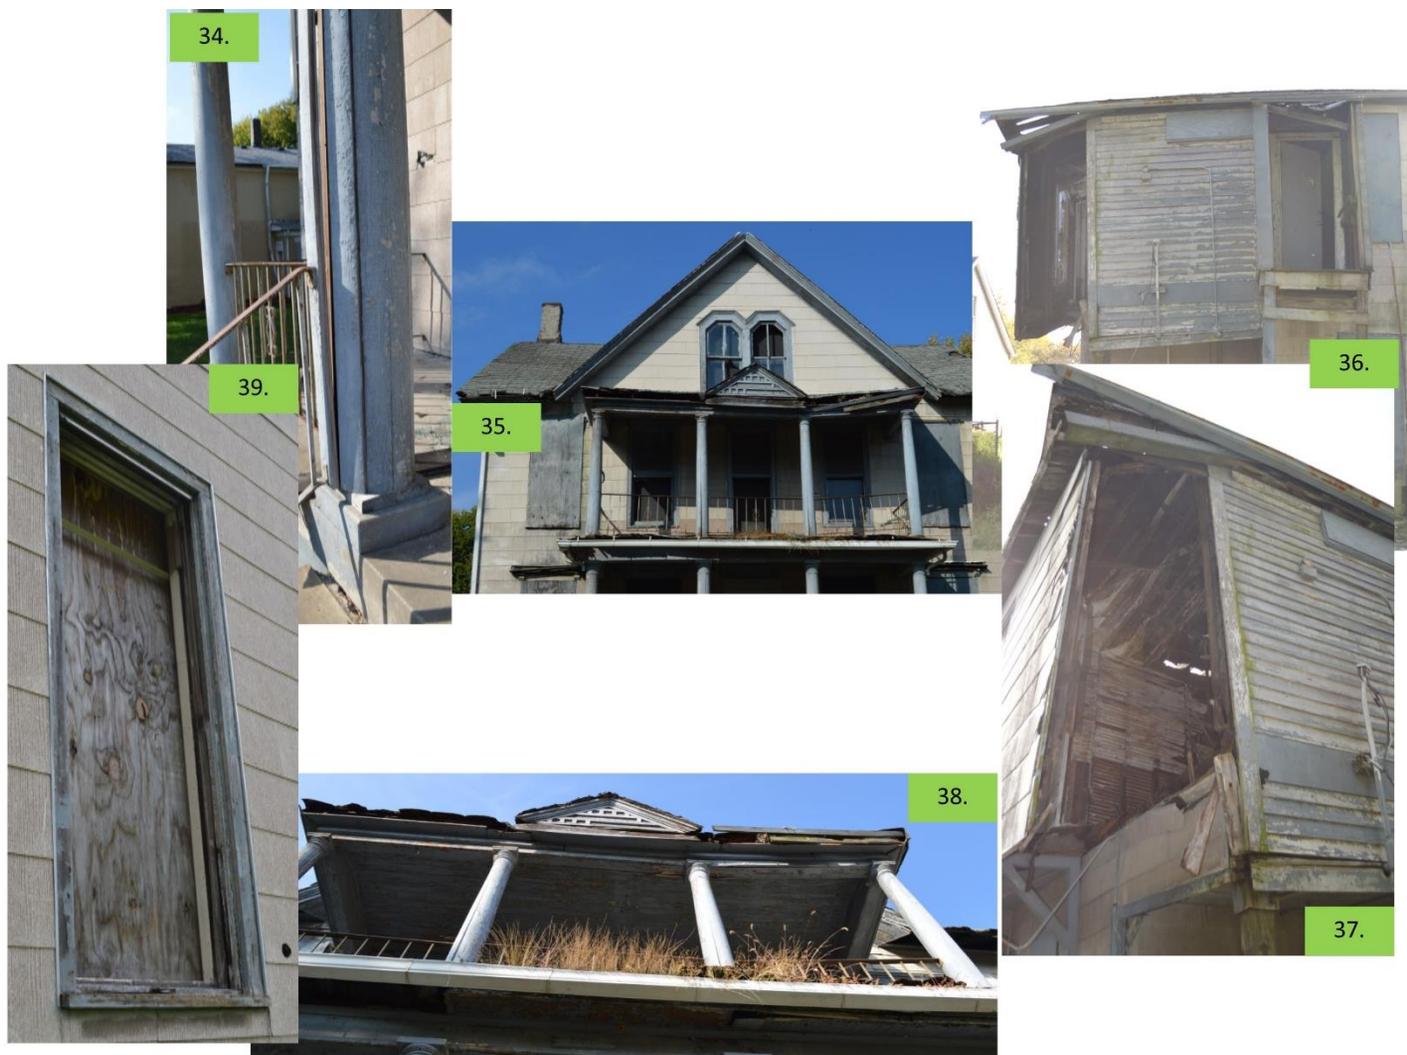
- The smaller northside room, a cantilevered section at the northeast corner of the building, is open to the elements at one corner and near collapse. It has lost some of its external bracing and is sagging under the weight of damaged framing and heavy exterior cladding. Should it completely fail and pull away from the house, other intact walls and framing could be compromised. (36, 37, 42, 43)

- Wood fascia and tongue and groove soffit materials are missing or damaged across all elevations. Metal K-gutters are in poor condition. (6, 10, 12)
- On the south elevation, an area that was observed only from the ground, the second floor porch roof and its decorative gable are sagging above wood columns whose individual boards are beginning to pull apart. The appearance may be somewhat exaggerated by extremely deteriorated fascia hanging across the roof edge. (35, 38, 39)

34. Looking W, S façade, delaminating column. 35. Looking N, S façade, sagging roof and bad soffit on porch. 36. Looking S, N elevation, sagging walls on second floor room in NW corner. Lap siding uncovered in this location. 37. Looking SW, interior of room in #37. Daylight at roof. 38. Looking N, S façade, deteriorated condition of porch and eaves. 39. Looking SE, W elevation, window trim partially covered by asbestos shingles.

| Stabilize Building, Enhance Appearance and Marketability (GRG) | | | | | Priority : 1 = High 2 = Moderate 3 = Low | |
|--|---|---|--|---|---|---|
| Rear Section | NE corner, N Elevation | 2 | Cantilevered section is dangerously deteriorated. | Add additional temporary support from ground level across second floor joists. Starting at the roof, remove entire cantilevered second floor section, retaining joists. Seal exposed interior walls with weatherproof materials. Retain reusable materials in dry area. | 1 | 1 |
| Porch | Ext, south Elevation | 1 and 2 | Grass is growing in second floor porch gutter; boards have detached and dropped across porch. First floor column is delaminating. | Assess safety of porch roof system before proceeding with work. If safe, remove organic material from gutter and detached boards. Repair or temporarily remove delaminated column after supporting area with temporary timber or 2x4 member. To maintain the home's appearance, repair and re-install. Railings should not be removed until appropriate historic replacements are ready for installation as they may be lending support to the structure. | 1 | 2 |

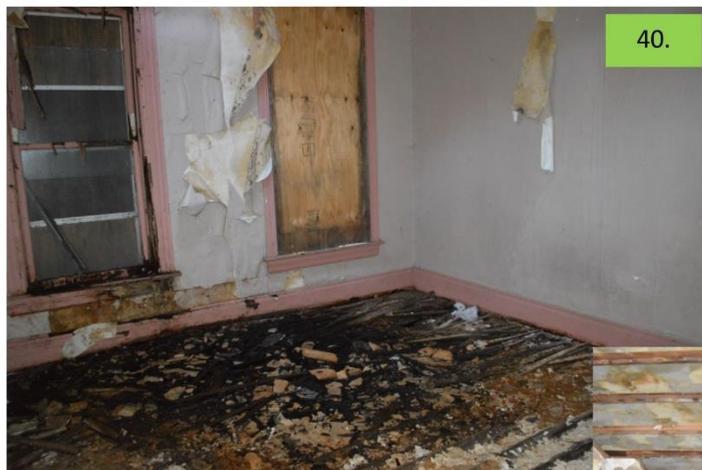
- Original doors and trim are intact, some with original finishes. (26, 27)
- Bedroom ceilings are severely damaged and floor boards warped from roof moisture. (40)
- There is some ceiling and floor damage to sitting room and dining room, but they and the hallway appear sound. (27,29)
- Animal scat (raccoon) was observed on second floor.

40. Looking SW, second floor, condition of floor in west bedroom.
 41. Looking SW, first floor, fallen plaster in parlor below bedroom.

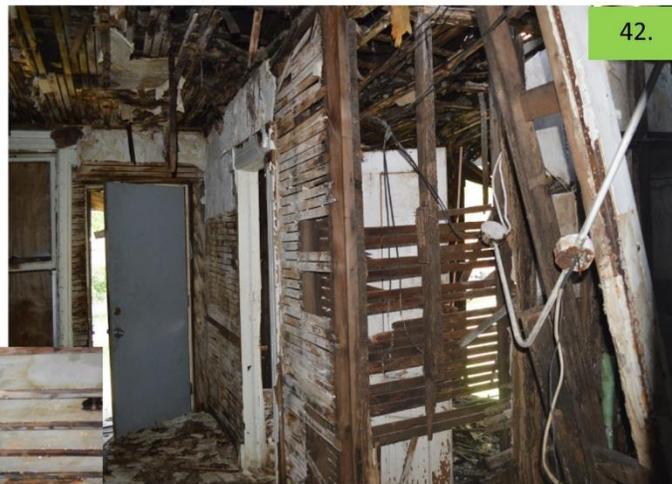
40. Looking SW, second floor, condition of floor in west bedroom.
41. Looking SW, first floor, fallen plaster in parlor below bedroom.
42. Looking N, second floor, room at NW corner; daylight is visible.

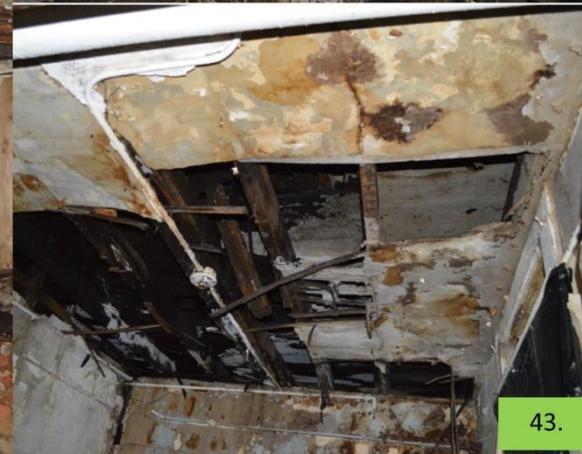
43.

- Electrical service is generally via wire mold on walls and ceilings and does not meet current code due to age and condition. (43)
- No plumbing is in evidence and kitchens and bathrooms have been removed or are located in inaccessible areas.
- Ducting for forced air furnace is intact in basement; some grates are missing.
