Marion Meginnis  
HP634  
Preservation Technology  
November 2016

## Nesbit Cottage

### The Case of the Tilted Cottage: Remediating the Impact of Pests and Moisture on a 19th Century Iowa Building

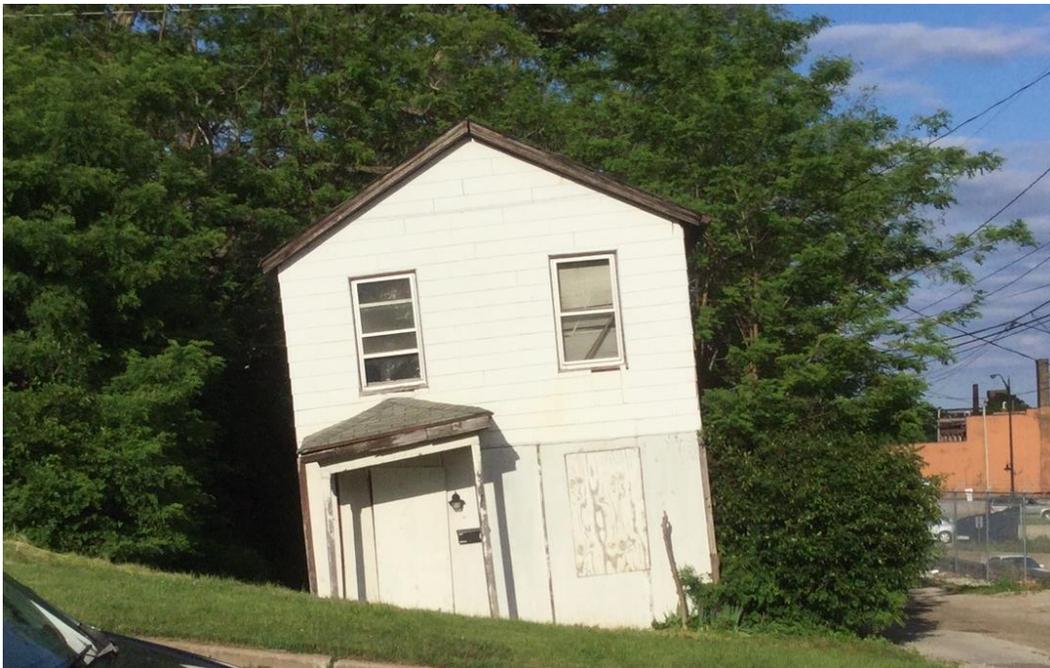
Figure 1 Looking east, the Nesbit Cottage prior to remediation showing building leaning to the north. June 1, 2015. GRG photo; used with permission.

does not enter buildings prior to demolition, and it is likely that the condition assessment was made by an exterior survey. The building had begun to lean toward the north, indicating issues with a collapsed foundation or sill. The acquisition by GRG removed 517 Ripley from the city's list. A 1910 photo of Ripley Street<sup>4</sup> offers a glimpse of the cottage sheathed in weatherboard and sporting a wood shingle roof and six over six windows.

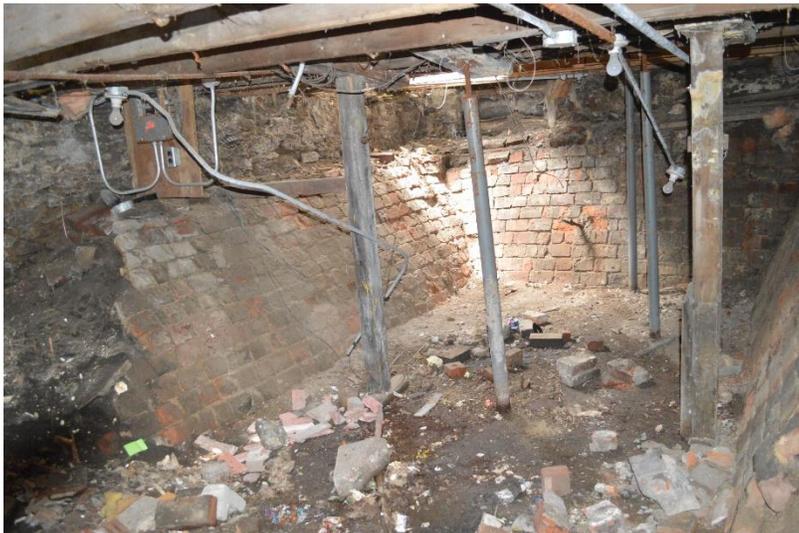
Figure 3 Looking southwest, battered brick walls in basement below limestone foundation. 5/25/2016 Author photo.

- The concrete block foundation at the rear was built without venting and the crawl space beneath was filled with blown in insulation.
- The substantial basement featured battered brick walls with a limestone rubble foundation set on top of the ledge above the brick walls. The floor had been laid with modern concrete.

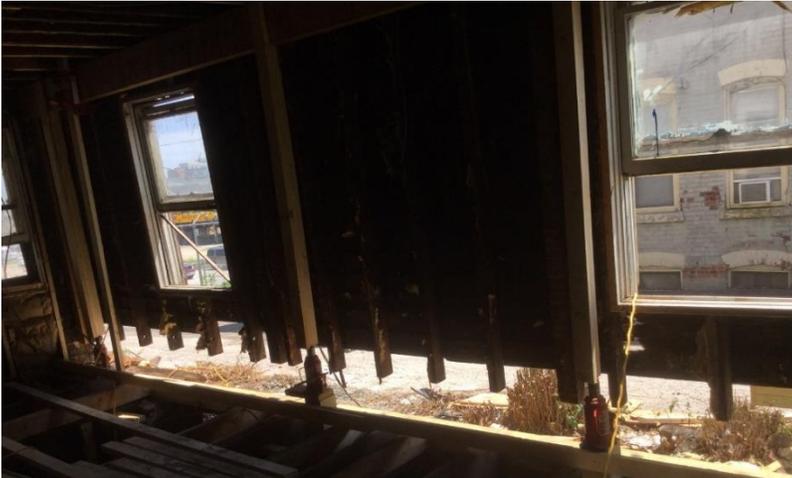
Figure 4 Looking southeast, south wall lifted for new sill, studs trimmed of rotted material and awaiting butt joining with good wood and sistered before being lowered into place. 7/14/2016 GRG photo; used with permission.

The north side support was jacked only enough to make it tight against the existing height of the first floor. However, on the south elevation, the supports were jacked an additional one to two inches off square to permit removal of its sill and replacement with a new member, to cut the damaged ends of the studs and posts off and butt join them to new ends and to sister them to the new sill.

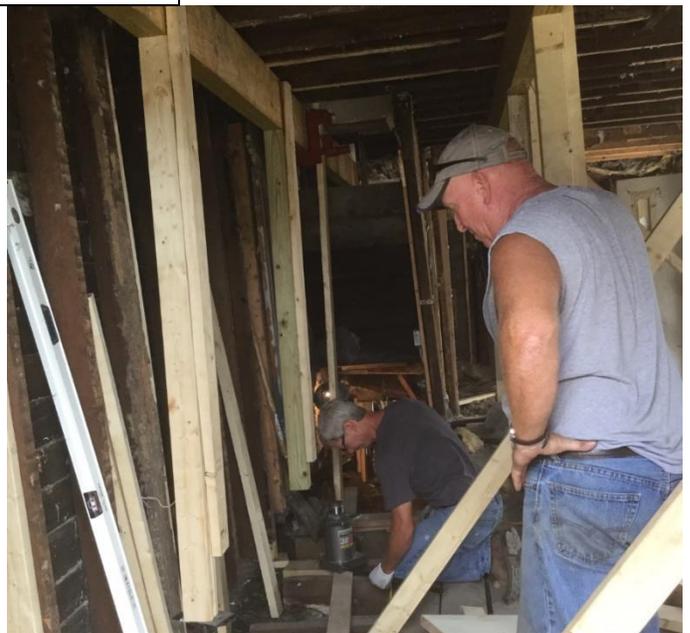
- The supporting wall posts on the north elevation had been destroyed by termites, in one case to a level of six feet. There was no evidence of current active termite damage in the building.

Figure 5 Right, looking north, north wall being supported by two temporary posts and beams as repairs are made to north wall. 7/19/2016. GRG photo; used with permission.

With repairs completed and with a solid wall on the south elevation, workers removed the temporary support along the wall and reset it close to the north wall, with the vertical posts set on the basement ledge. That gave the building the support of two temporary beams along the more damaged area. The new sill was installed and studs and posts were remediated.

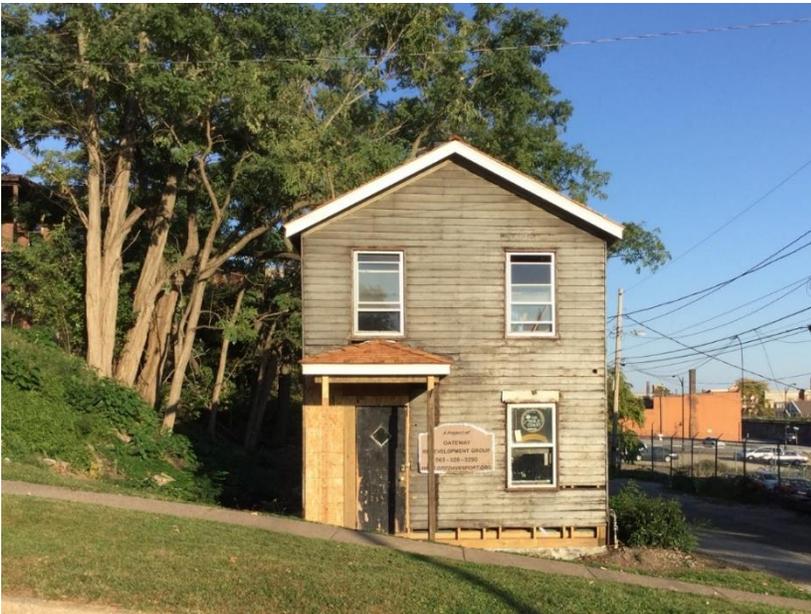
Figure 6 Looking east, Cottage after remediation to sills, new roof and removal of later cladding. 10/11/2016 GRG photo; used with permission.
