Building Condition Assessment

The George Krabbenhoeft House c 1888

716 W. 5th Street, Davenport, Iowa

Marion Meginnis
HP 634 Preservation Technology

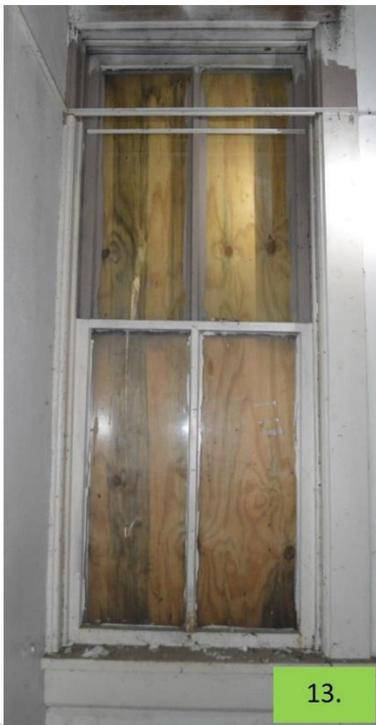
13.

- Original windows are either still in openings or set to one side. The muntin pattern on some sashes has been altered. (13, 15)
- The condition of the wood siding underneath the asbestos shingle is unknown. Only a small portion is visible; in those areas, the lap siding appears sound. (36)

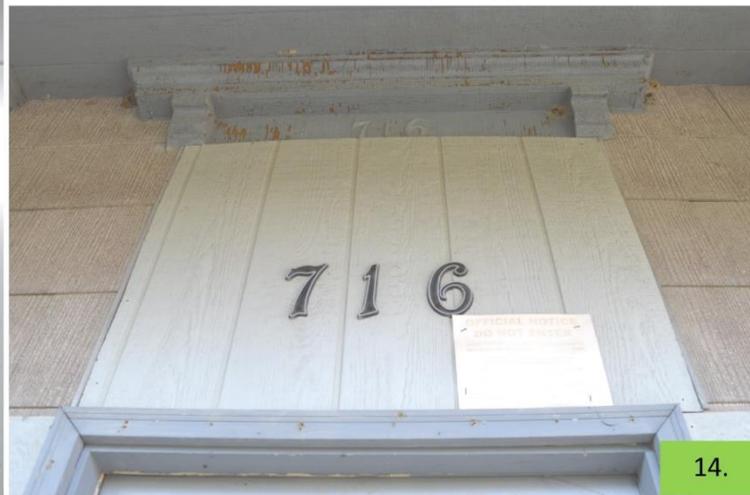
14. Looking N, front porch. Original hood above door also found above windows.

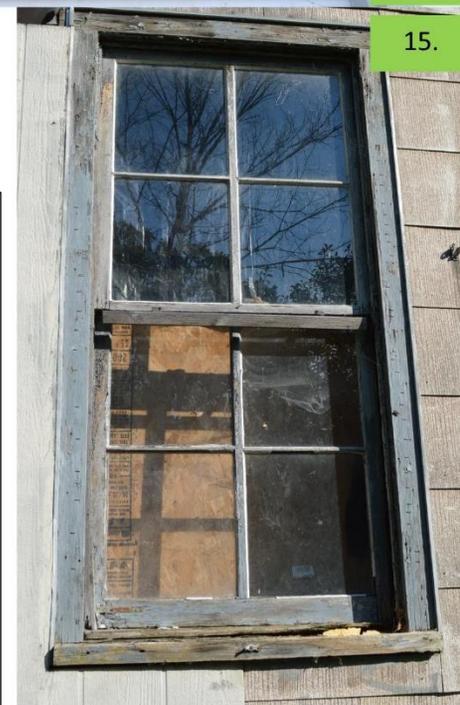
15. Looking E, W elevation. Four over four window matching that found in Rindler photo, (#3).

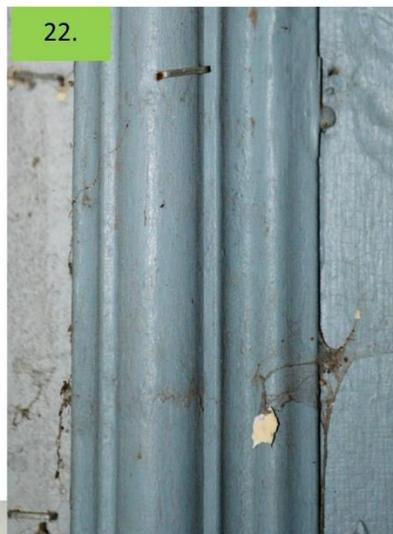
22.

- Wood floors are generally in good condition. One is covered with vinyl or asbestos tile. (20, 23)
- Some damage is present to ceilings in front parlors and to floor in east parlor due to moisture from above. (24, 41)
- Paint is peeling from ceilings and walls. (18, 24)
- Original trim, doors and most staircase elements are intact. (18,22)

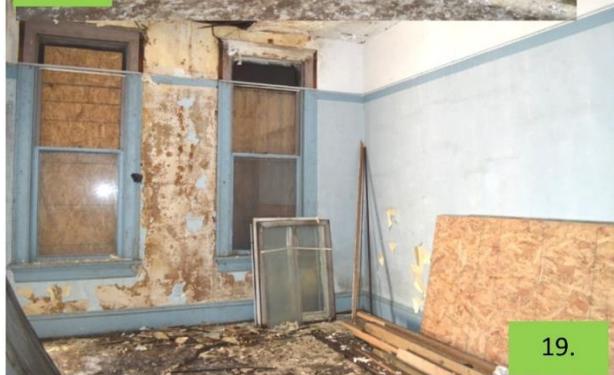
19.

- The cross gable section of the roof is sound but shingles are in poor condition. Roof holes approximately two and three feet in diameter located at two valleys near the south elevation are allowing water to enter the interior at the attic. Damage created by this condition is evident even in parts of the first floor. (19, 24, 28, 32, 40, 41)

- All exterior doors are modern metal units inappropriate to an historic home. (25)
- Window openings are securely boarded on the exterior, with no moisture apparent on interior surfaces. Some sills have failed. Application of the asbestos siding might have brought changes to exterior window trim and casings. Full assessment will require removal of boarding materials. (19, 39)

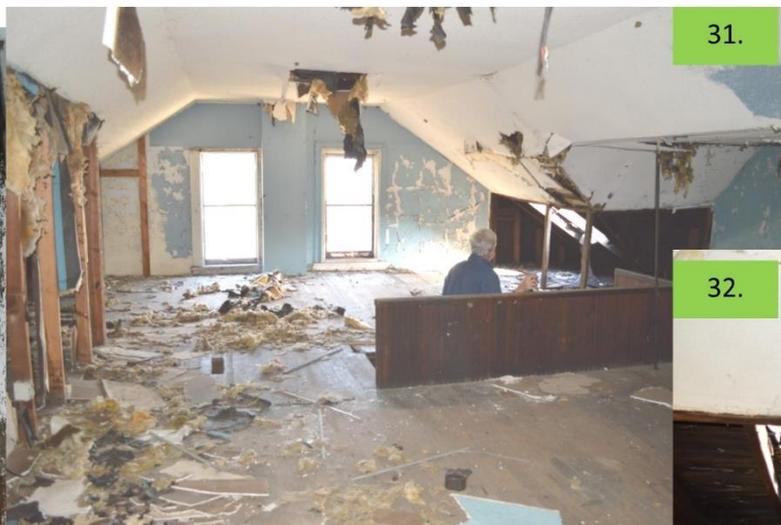
31.

- Holes at valleys and floor damage are clearly visible. (32)
- Balance of flooring seems structurally sound.
- Staircase from second floor is structurally sound.
- There is some damaged to finished ceilings due to water incursion or vandalism. (31)
- Some sashes are missing with windows covered by storms.

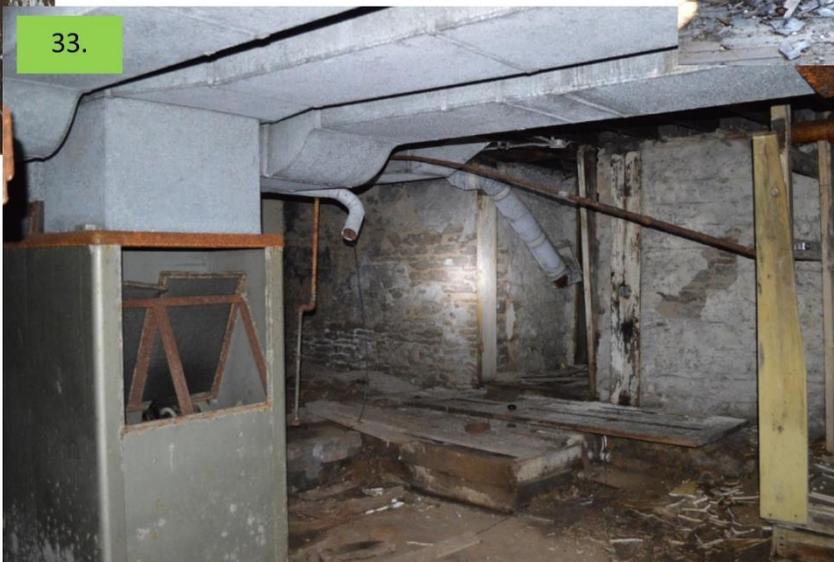
33. Looking NW, basement. General condition.

- The second floor east side bay retains its original siding and trim and appears structurally sound but in need of paint. (8, 9)
- On all sides, viewed from both the exterior and interior, the foundation appears square and true. It has lost a small amount of parging at some corners and basement window openings and in the basement interior, a plaster coating on the limestone has detached. (16, 33)
