Building Condition Assessment

The George Krabbenhoeft House c 1888

716 W. 5th Street, Davenport, Iowa

October 2016

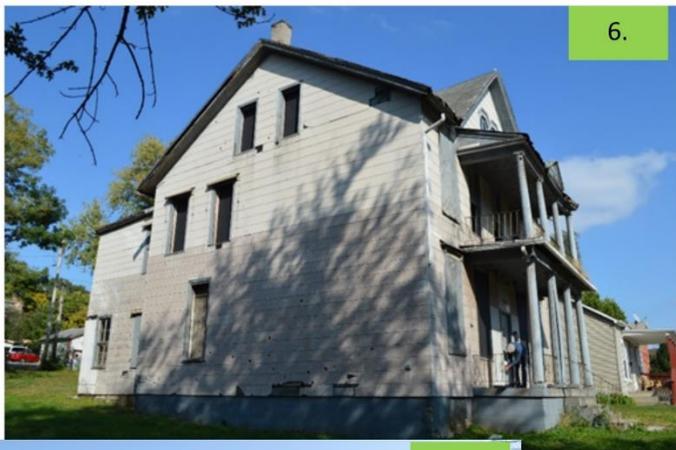
- 6. Looking NE, W elevation. Fascia missing
- 7. Looking NW, S and E elevation.
- 8. Looking NW, E elevation, front.
- 9. Looking NW E elevation, rear.
- 10. Looking S, N elevation.
- 11. Looking SE, N and W elevation.

- Wood fascia and tongue and groove soffit materials are missing or damaged across all elevations. Metal K-gutters are in poor condition. (6, 10, 12)
- On the south elevation, an area that was observed only from the ground, the second floor porch roof and its decorative gable are sagging above wood columns whose individual boards are beginning to pull apart. The appearance may be somewhat exaggerated by extremely deteriorated fascia hanging across the roof edge. (35, 38, 39)

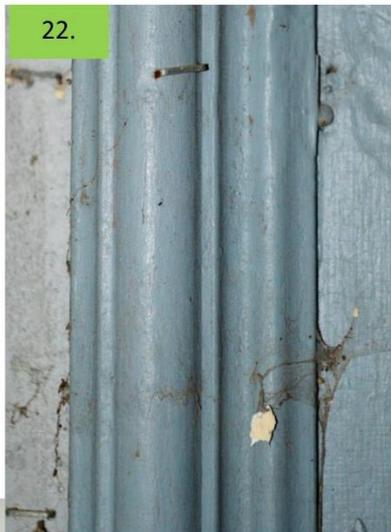
22.

- Wood floors are generally in good condition. One is covered with vinyl or asbestos tile. (20, 23)
- Some damage is present to ceilings in front parlors and to floor in east parlor due to moisture from above. (24, 41)
- Paint is peeling from ceilings and walls. (18, 24)
- Original trim, doors and most staircase elements are intact. (18,22)

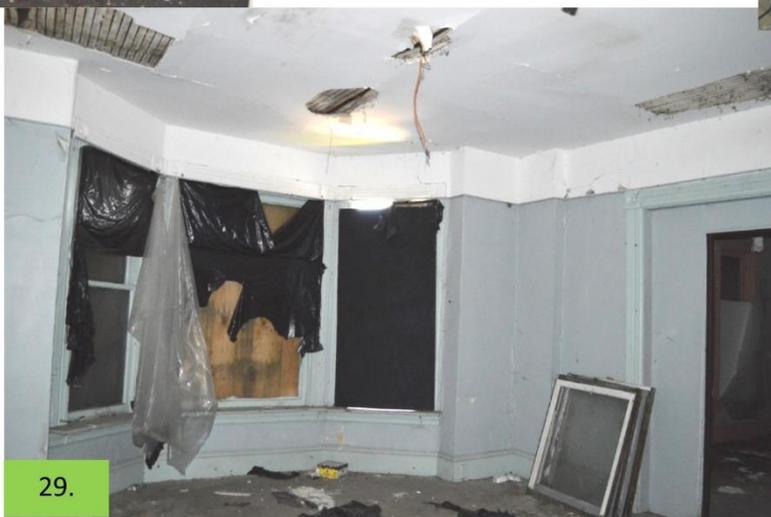
29. Looking SE, sitting room and bay.

- Original doors and trim are intact, some with original finishes. (26, 27)
- Bedroom ceilings are severely damaged and floor boards warped from roof moisture. (40)
- There is some ceiling and floor damage to sitting room and dining room, but they and the hallway appear sound. (27,29)
- Animal scat (raccoon) was observed on second floor.

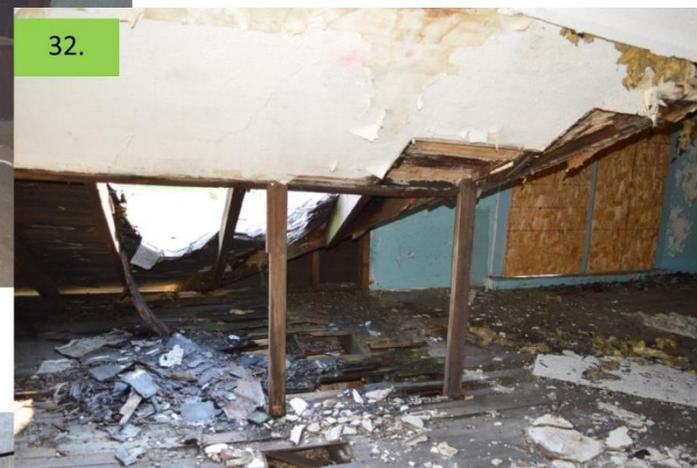
32.

- The cross gable section of the roof is sound but shingles are in poor condition. Roof holes approximately two and three feet in diameter located at two valleys near the south elevation are allowing water to enter the interior at the attic. Damage created by this condition is evident even in parts of the first floor. (19, 24, 28, 32, 40, 41)
